Warnham Mill Pond Sluice Failure (2015) Mill News #142 (January), 22

Warnham Mill Pond Sluice Failure *Nigel Harris*

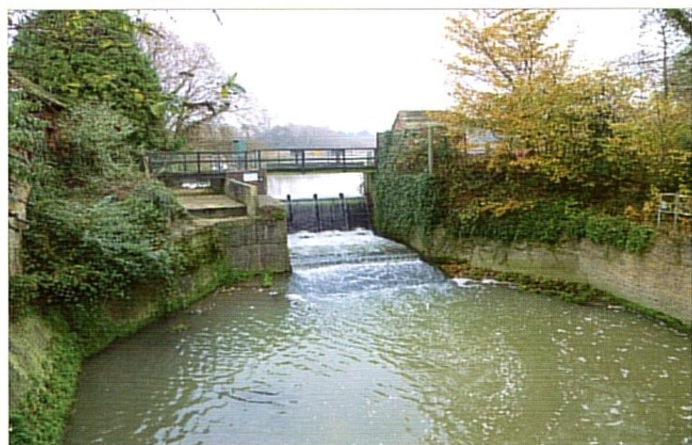
The problem sluice at Warnham Mill. Picture - Nigel Harris

The water level in the pond can be controlled by a computerised sluice gate. Sadly, it was reported locally that on the morning of the 6 October, a fault (possibly with the alarm sensor) meant that the gate was opened a significant amount. Attempts to close the gate, including a manual override system, failed.

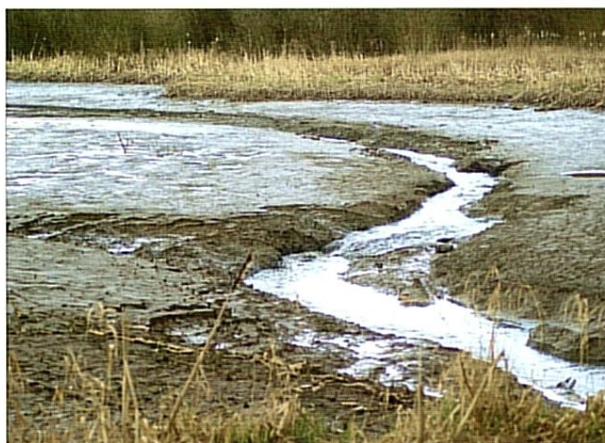
The drained mill pond. Picture by Neil Henry

Within a short time the Mill Pond had been entirely drained. Wardens did all they could to save as many fish as possible, but with the additional loss of organisms and invertebrates in the top layer of silt, it is said that it will probably take at least five years for the mill pond to be self-sustaining once again.

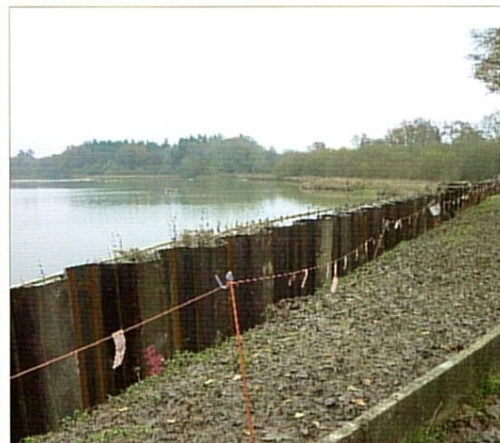
The sheet piling of the Warnham mill dam. Picture - Nigel Harris

The work involves installing steel sheet piling on the face of the dam and making the back more stable. The total project cost is £1.1 million which is jointly funded by DEFRA and Horsham District Council.
